This kit provides a fix for the following instances:

Black and Blue/White wires:

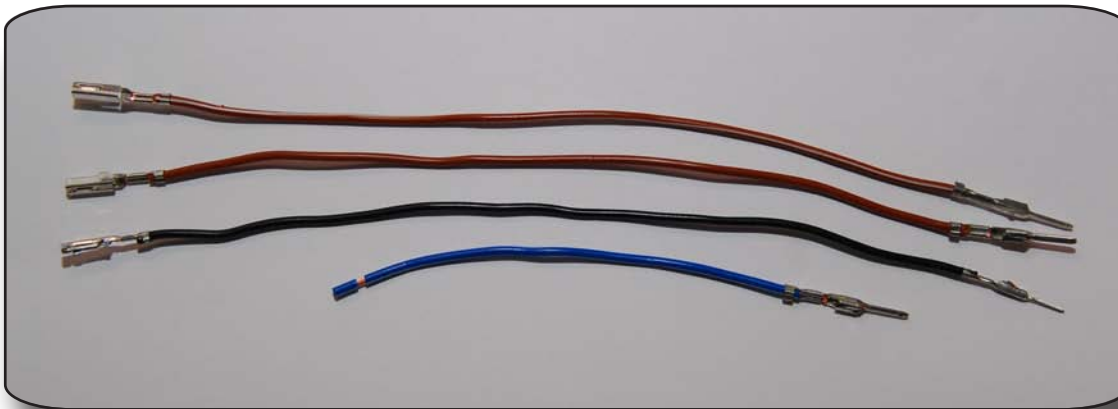
Figure A.

Locate the plastic bag that houses the 4 wires needed for this modification. Remove the wires from the plastic bag. (See Figure A.)

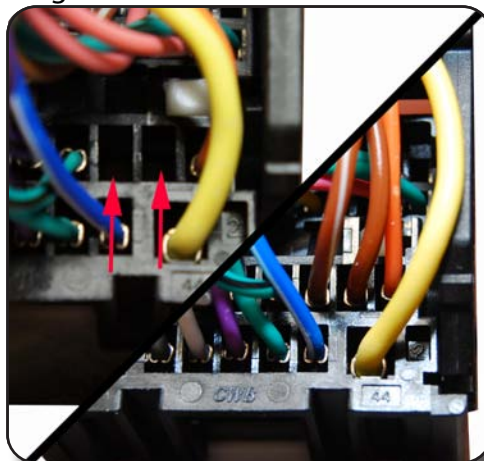
With the white insert still in the unlocked position, you will want to insert the Brown and Brown/White wires into this connector. Locate pin #35 and insert the female side of the Brown/White wire into the slot until it clicks and locks in. (Pin 35 is located next to the Green/Black wire in the harness). Locate pin #36 and insert the the female side of the Brown wire into the slot until it clicks and locks in. See Figure D.

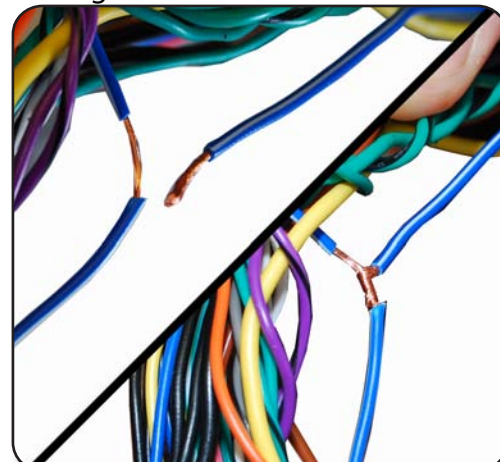
Figure F.

Once all of the pins have been inserted into the connectors, you will need to remove the cloth tape around the "T" junction to expose the Blue/White wire. You will then need to remove about 1/2 inch of the shielding to expose the wire. Strip and wrap the wire coming from pin #43 on to the wire that we just removed the shielding from. You will then need to solder and tape the connection. Replace any tape that was removed and connect the harness back to the factory radio and vehicle. Secure the radio back into the dash and test to ensure that all functions work as they should.
